Site Analysis American Creosote Works, Inc. Jackson, Tennessee

EPA Region 4
and OERR

Remedial Response and
Site Analysis
American Creosote Works, Inc.
Jackson, Tennessee

by
Judith M. Begley, Imagery Analyst
The Pionetics Corporation
Warrenton, Virginia 22186

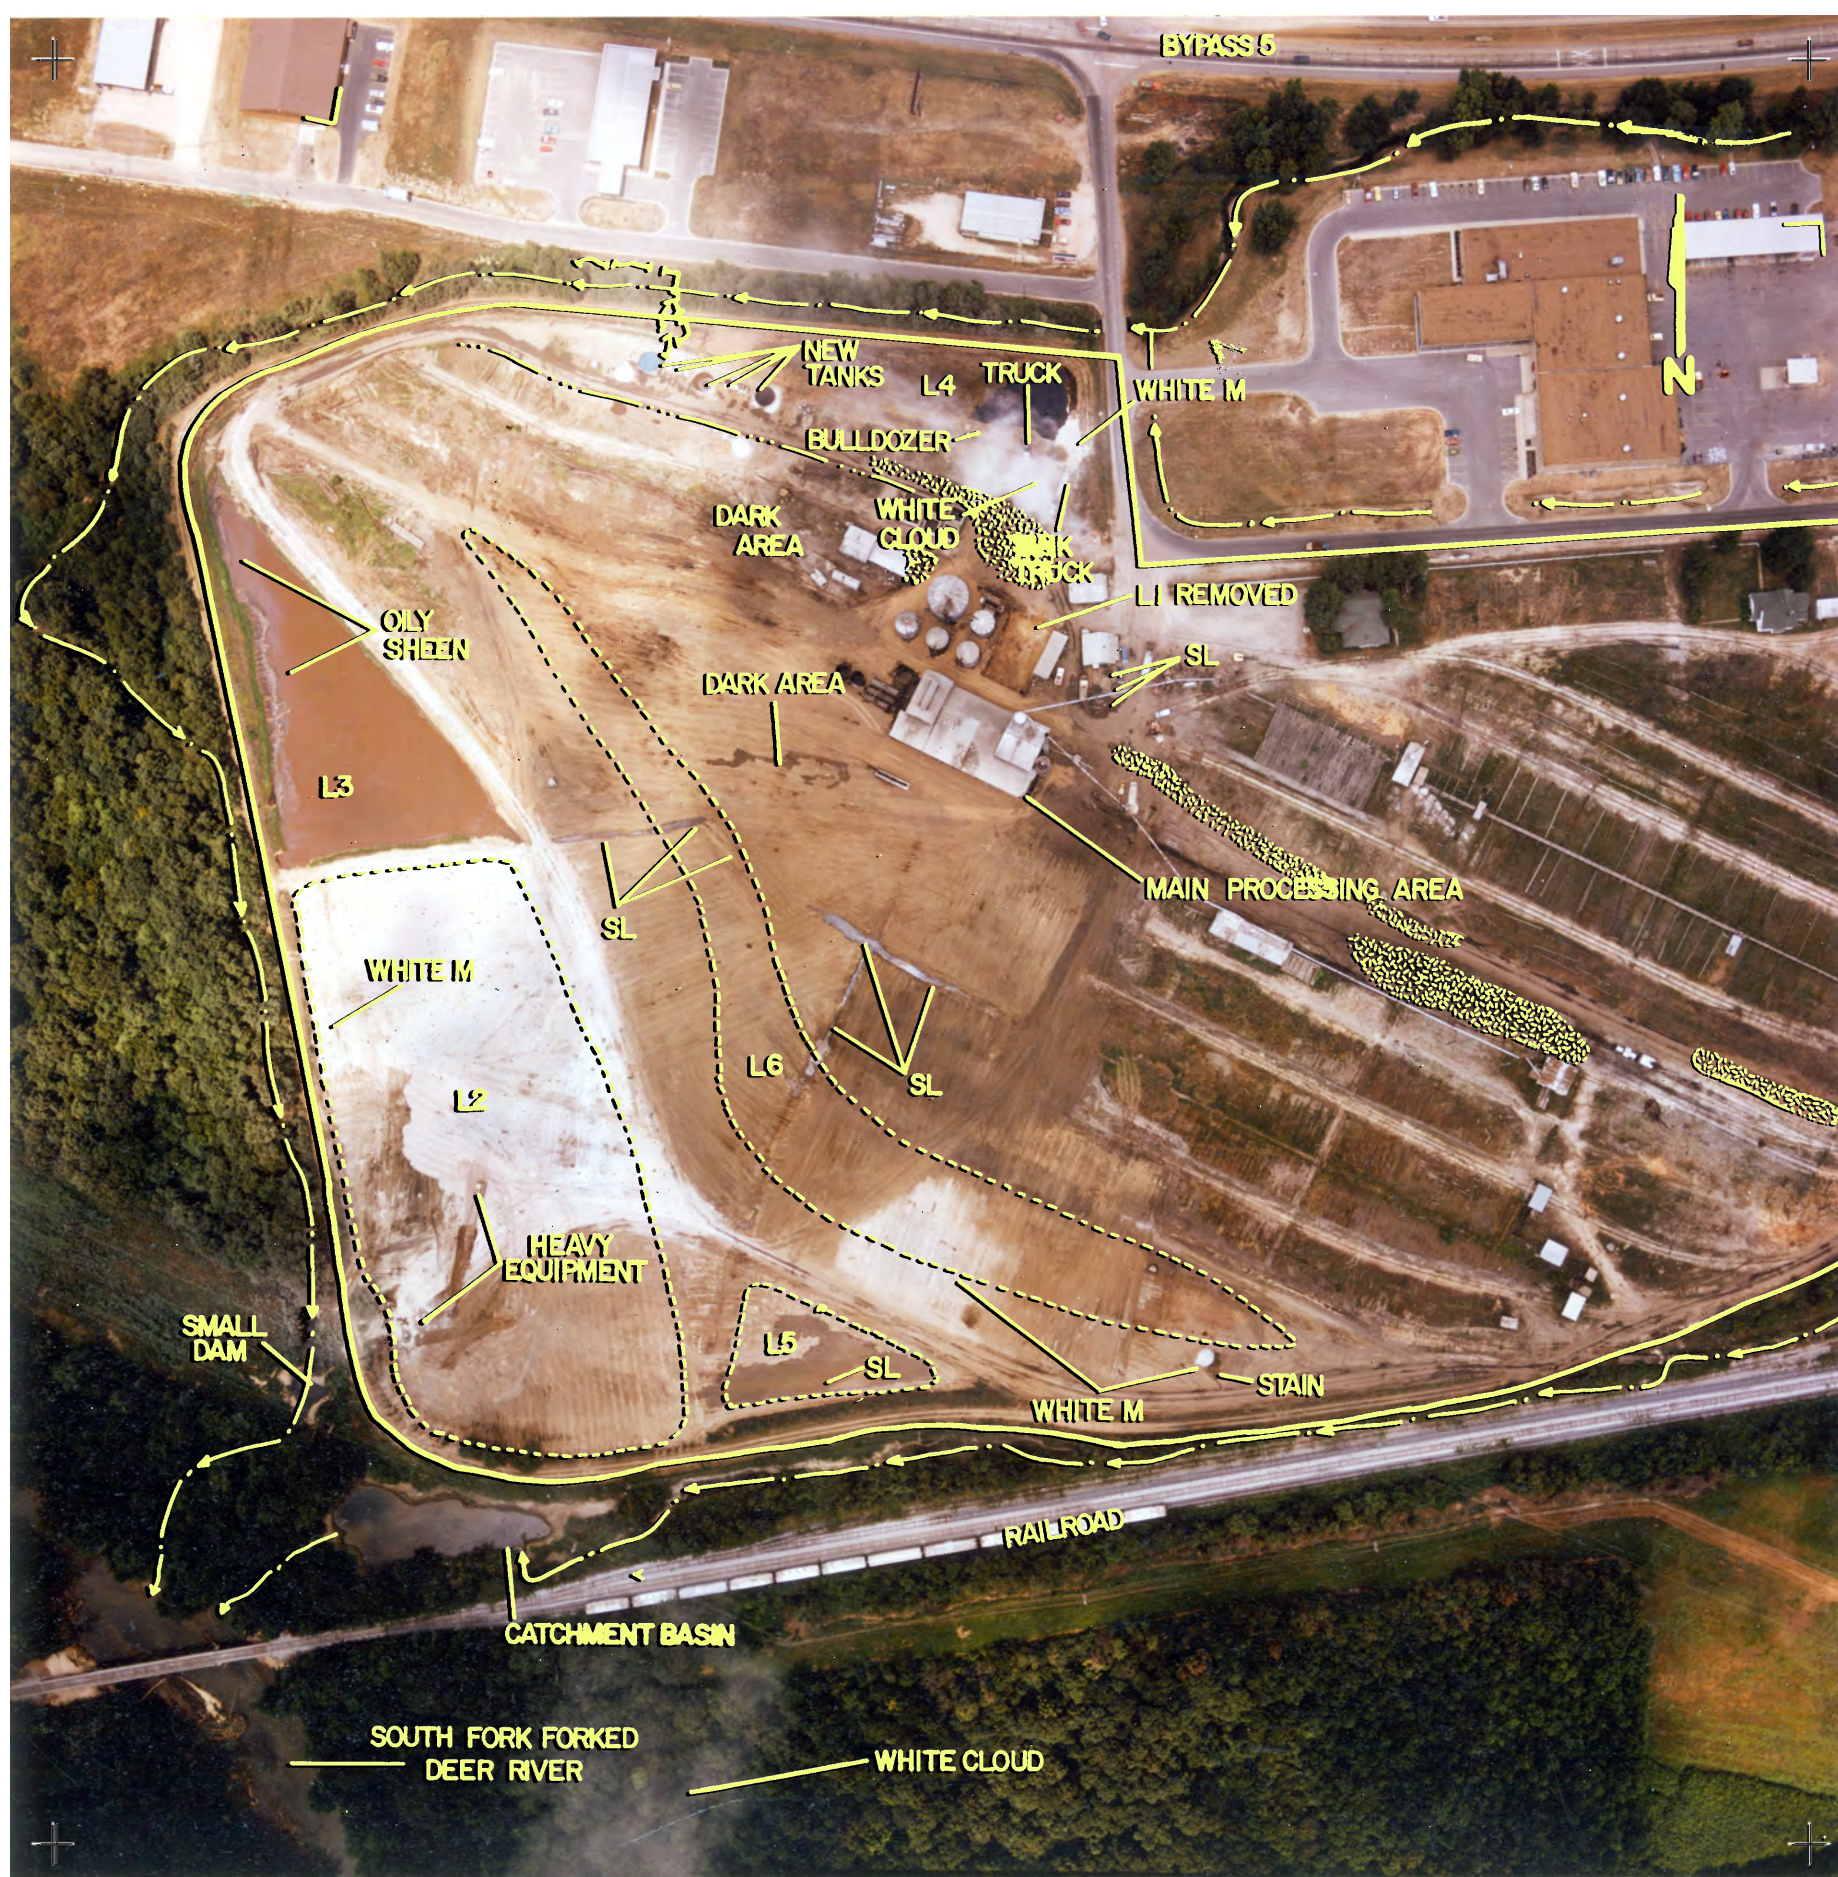
Figure 9. American Creosote Works, August 4, 1983.
Approximate scale 1:2,500.

A large amount of fill and cover material (not annotated) has been deposited on the western portion of the site since June 22. Graded earth now covers nearly all of the dark-toned areas previously located in and around the main processing area and the former wood storage areas. A patch of ground where white material has been graded into the soil surface is visible northeast of L5, and a small pile of white material appears to have been deposited on top of a stained area east of L5. A large amount of white material has been deposited in L2 and a smaller amount at the east end of L4. The two trucks and the bulldozer near L4 may be involved in depositing the white material. A white cloud visible over this area may be a result of the dumping of the material. The white cloud visible in the southern portion of the photograph was visible on an earlier frame of photography (not shown), originating at the point where heavy equipment is spreading the white material in L2.

The revetment between L2 and L5 has been removed, and both lagoons have been drained and graded. A pool of brownish standing liquid is visible in L5. The bottom of L3 is covered with a mottled brown and green liquid that has an oily sheen on its surface. The east end of L4 has been revetted off from the rest of the dry lagoon and contains dark liquid. L1 has been removed, leaving a shallow earthen hole.

Three large open tanks and a number of smaller tanks (annotated as New Tanks) have been placed along the north edge of the site. Hoses and small pipelines are visible around these tanks, including one large light-colored hose that runs north from the tank offsite and then west, possibly terminating in the creek.

A dark area, east of the main processing area, along a railroad spur (not annotated) has consistently been one of the darkest areas onsite. This area appears heavily stained and has not been covered or graded. Most of the other dark areas appear to have been stained after June 22, 1983. The dark area northeast of former L6 may be a stain caused by material that was dumped on the surface or that migrated up from under the surface.

Southeast of the main processing area are some smaller buildings and old wood storage areas (not annotated). This area has begun to revegetate with grass and shrubs. The soil in this area generally appears to be a dark grey in color, and no signs of earthmoving, filling or covering are visible.
